FOUNDATION PROBLEMS OF KONYA ALAEDDİN MOSQUE AND IMPLICATION OF REMEDIAL MEASURES

H.T. Durgunođlu(1), T. Karadayılar(2), C. G. Olgun(1)

ABSTRACT

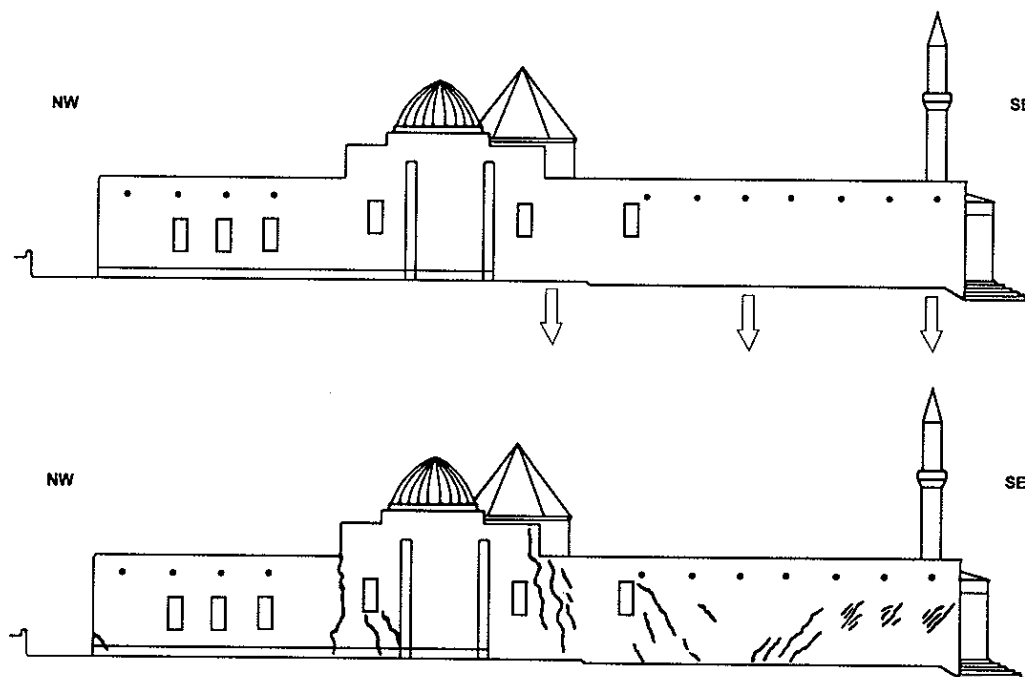
It has been determined from the evaluation of performed subsoil investigations and study of crack locations that the foundation of the structure has been subjected to differential settlements. The foundation subsoil has been observed to be highly decomposed due to leakage from the water reservoir located below the southern face and eastern corner of the mosque, which has been used for long years as municipal water storage. Finite element analysis has been performed to evaluate and model the deformation pattern expected to occur within the subsoil located below the mosque. The settlement mechanism and the resulting crack pattern along the northwest-southeast wall are shown in Figure 2.

Figure 2. Settlement mechanism and resulting crack pattern along SW-NE wall
