# PRELIMINARY FINDINGS FROM AN INVESTIGATION OF IMPROVED GROUND PERFORMANCE DURING THE 1999 TURKEY EARTHQUAKES

James R. Martin II<sup>1</sup>, C. Guney Olgun<sup>1</sup>, James K. Mitchell<sup>1</sup>,  
H. Turan Durgunoglu<sup>2</sup>, Canan Emrem<sup>3</sup>

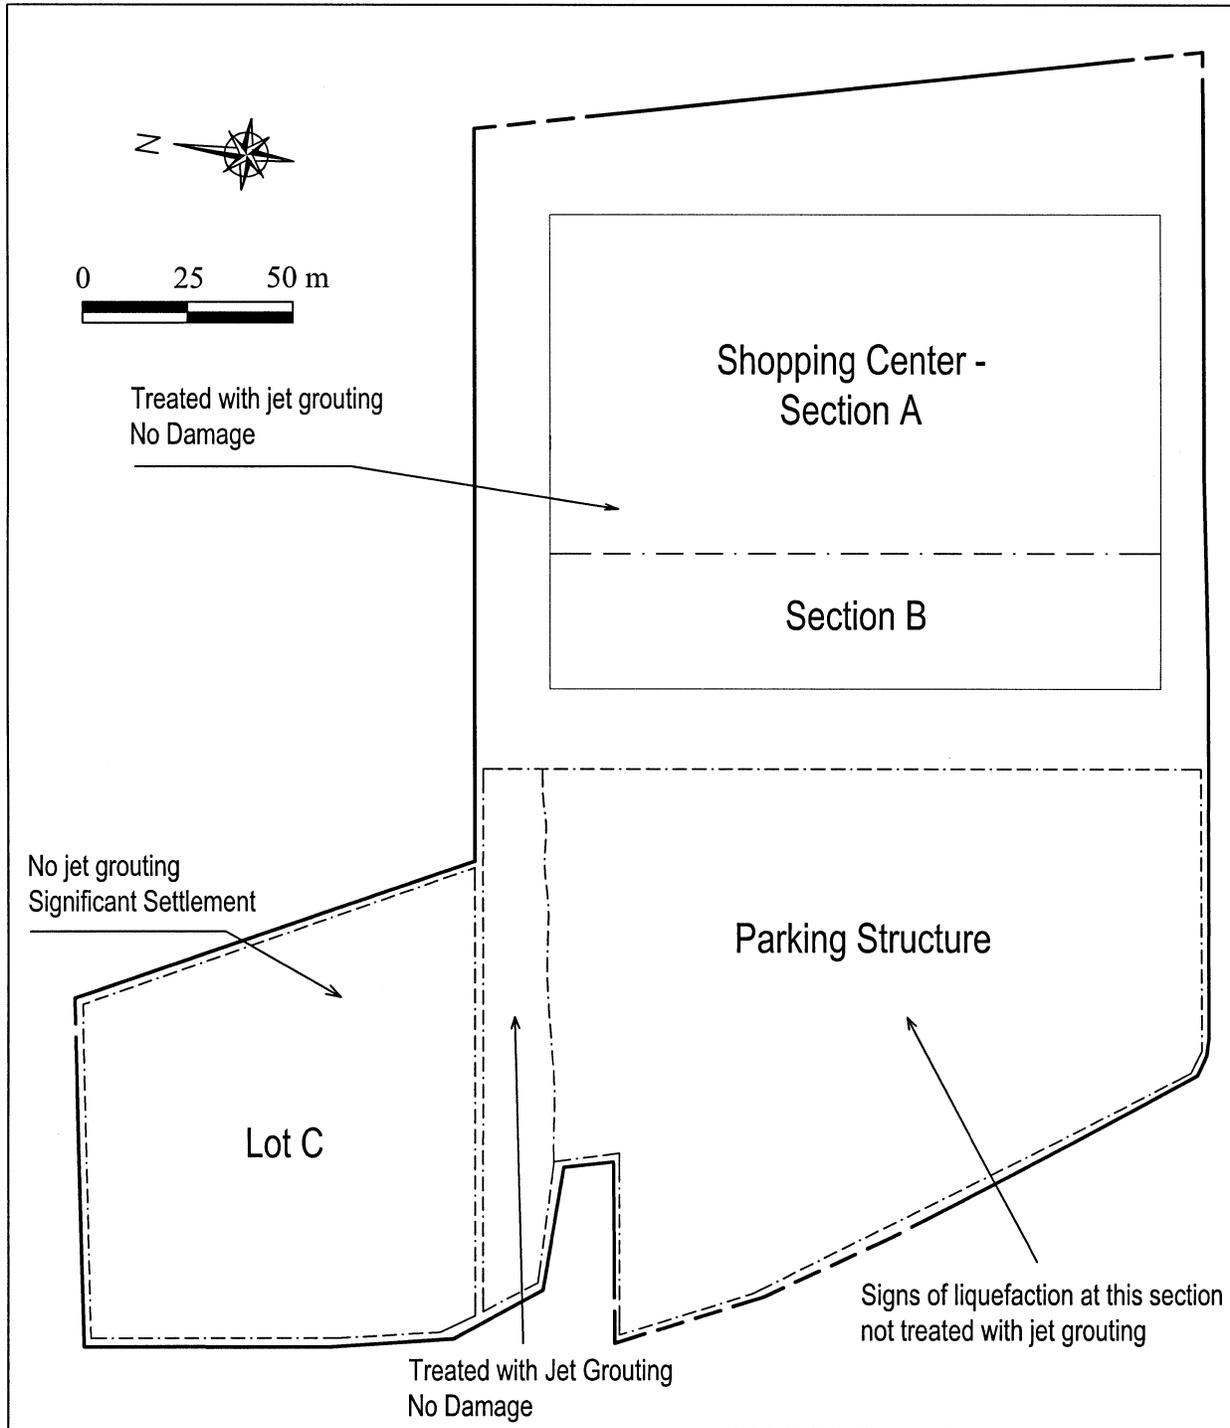
Figure 2. Carrefour Shopping Center – site plan

the supermarket building and no noticeable settlements or ground damages were observed anywhere at the site except in the untreated portion of the Parking Structure area and Lot C.

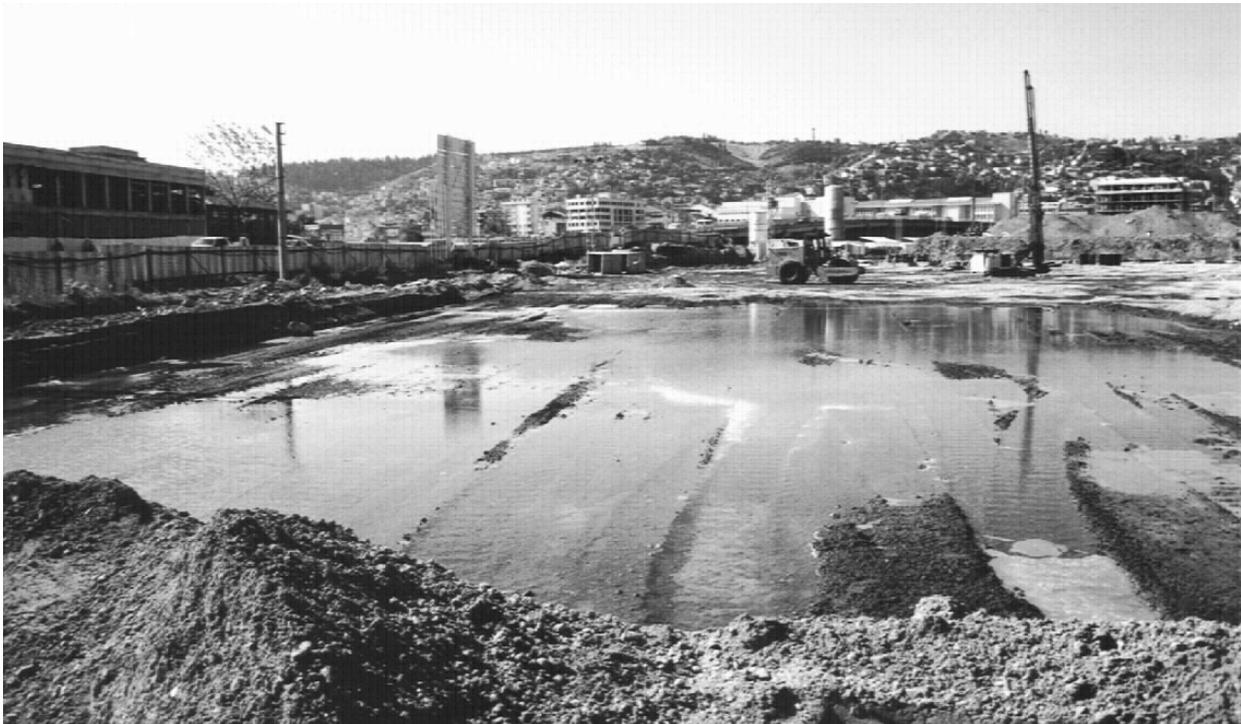
Site personnel reported that the untreated portion of the Parking Structure area was inundated with about 7 to 10 cm of water that temporarily ponded on the ground surface the morning following the earthquake as shown in Figure 3. It may be remembered that wick drains were installed in this area, and a surcharge fill was removed prior to the earthquake. Field inspections determined that the water originated from the underlying soil deposit via drainage through the wicks. It is fortuitous that settlement-measuring devices were in place at Lot C during the earthquake. By comparing pre- and post-earthquake readings from within the soil profile, the earthquake-induced settlement of the sand layer could be closely estimated. It was found that 8.0 cm of settlement occurred in the 2 m-thick loose silty-sand layer, presumably due to pore pressure build-up and subsequent reconsolidation via drainage through the wicks. It is also possible that the wick drains provided partial drainage during the earthquake, although the silty sand is not expected to be free-draining. To our knowledge, this type of earthquake-induced settlement measurement is unprecedented and provides an opportunity to better understand saturated sand behavior under strong ground shaking. Also, the measured settlement of 8.0 cm in the loose sand layer compares well with the 7 to 10 cm of water ponding on the surface, as the amount of extravasated water should be reflective of the volumetric strain induced in the sand layer. It is important to note that no surficial ground disruptions, such as sand boils, occurred at this location. The wick drains are thought to have prevented liquefaction and/or provided efficient drainage of the sand during reconsolidation, although significant settlements still occurred.

Figure 3. Ponding of water at portions of the parking structure area that were not yet treated with jet grout columns, Lot C under the preload fill is visible at the back – photograph taken the morning after the earthquake from the site border looking north

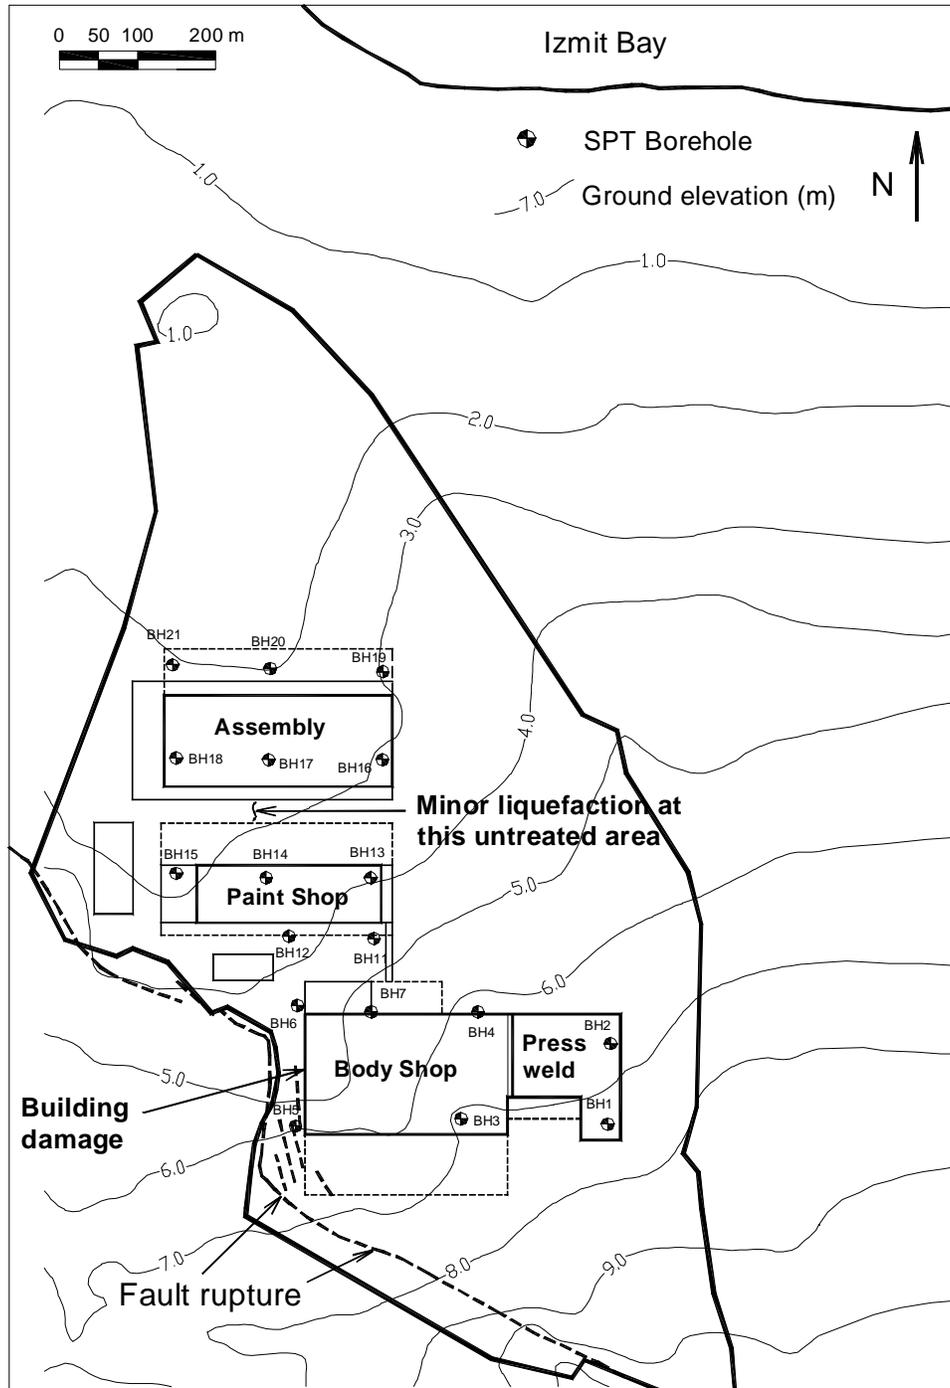
Figure 5. Ford plant – site plan

Following the earthquake, a visual inspection of the plant revealed significant earthquake-related damages. The most prominent observation was that the entire site underwent a global subsidence of about 2.5 m due to movements associated with the surficial fault rupture passing along the western plant boundary. The Body Shop, located closest to the fault rupture, underwent differential foundation movements of about 1 m, resulting in severe structural damage to the building. No signs of obvious liquefaction were found at the building and it is presumed that most of the damage was fault-related; however, it is possible that liquefaction-related phenomena may have played a role. The Body Shop is being demolished and re-built.

Small sand-boils and limited settlements, indicative of minor liquefaction, were observed in an open area between the Assembly Building and Paint Shop where the soils were not treated. Lateral spreading was observed along the waterfront in the general vicinity of the plant, but no spreading or any other signs of liquefaction were observed anywhere at the site. The liquefaction appears to have been confined to areas where the soils were unimproved. This difference in behavior between untreated and treated ground suggests that the soil treatment was effective in reducing liquefaction-related damages.
