Earthquake Performance of Reinforced-Earth Embankment Subjected to Strong Shaking and Ground Deformations

Abstract: Reinforced-soil structures, such as mechanically-stabilized embankments and soil-nailed walls, have proven to be feasible alternatives to conventional earth retaining structures. Although design methods for static conditions are well established, there is still a gap in our knowledge regarding seismic performance of such structures. The 1999 Kocaeli Earthquake (M7.4) in northwestern Turkey provided the opportunity to study the field performance of a double-walled reinforced-earth (RE) embankment designed according to procedures essentially same as current guidelines used in the US. The RE embankment formed the northern approach for the Arifiye Bridge Overpass and was investigated following the earthquake. The embankment was located just a few meters from the ruptured fault and subjected to strong ground shaking and significant permanent ground deformations. Unanticipated liquefaction-related settlements also occurred beneath the embankment. Ground shaking at the site was much higher than what was accounted for using the k_h design value of 0.1. Estimated peak ground

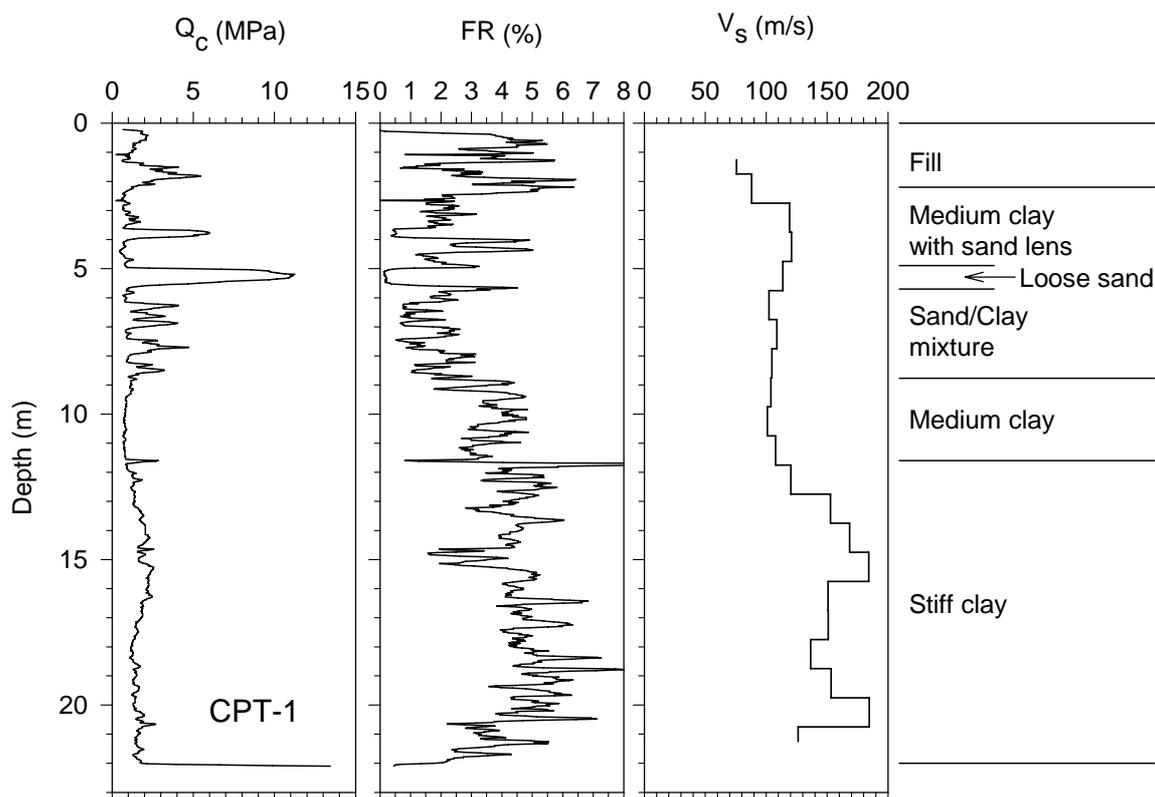
embankment. CPT sounding and shear wave velocity measurements from one of the test locations are shown in Figure 5. The upper 5 m of the profile consists of 2 m of loose silty/clayey sand fill with average Q_c values of 2.5 MPa underlain by a 3 m-thick medium clay layer with Q_c values of about 1.5 MPa. The clay is underlain by a 1 m-thick stratum of clean sand with an $I_c < 1.5$ and an estimated fines content $< 5\%$. Average values of normalized clean-sand-equivalent tip resistance ($q_{c1,CS}$) for the sand are 120. As shown later, this layer is liquefiable under moderate levels of ground shaking. A mixed stratum of clay with lenses of interbedded sand is encountered below the sand and extends from a depth of 5 m to 8 m. Normalized clean-sand-equivalent tip resistance ($q_{c1,CS}$) for this stratum is fairly uniform, averaging 80. A medium-to-stiff clay stratum with an average Q_c of 2 MPa extends from a depth of 8 m down to 22 m where the CPT was terminated. The water table was encountered at a depth of about 2 m.

As shown in Figure 5, shear wave velocities average about 150 m/s throughout the 22-m deep profile, increasing from 70 m/s to 130 m/s within the first 10 m, and then quickly increasing to 150-200 m/s and remaining fairly uniform down to the explored depth of 22 m. The site classifies as NEHRP “F” due to the presence of liquefiable sediments; otherwise, based solely on the shear wave velocities, the site would classify as NEHRP “E” (3).

Figure 5 CPT sounding between the culvert and the reinforced concrete abutment (CPT-1)

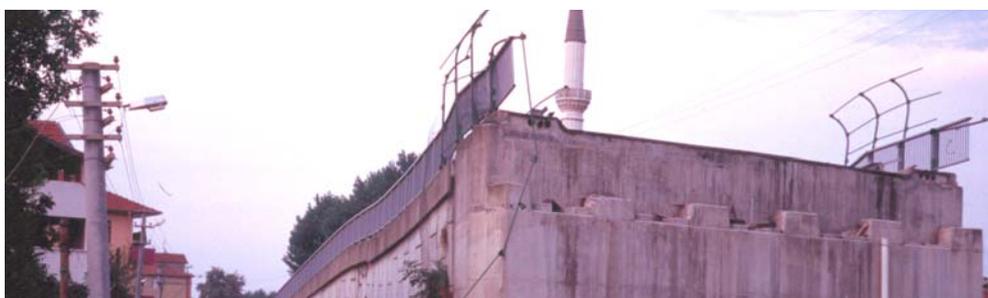
In addition to fault-related ground deformations, foundation settlements of up to 25 cm were observed. The abutment and the damaged RE structure are shown in Figure 6, where ground cracks, settlements, and signs of distress on one side of the wall are visible. The resulting differential wall settlement caused the facing panels to become separated and misaligned, which allowed spillage of some backfill material, as shown in Figure 7. The maximum out-of-plane wall panel displacement was about 10 cm and occurred at 3 m or one-third of the wall height from the base. A schematic illustrating the wall damage is shown in both side and plan view in Figure 8. It appears that the heavy embankment and the relatively strong fill underneath the wall (2-m thick dry crust) punched through the soft foundation soil forming a localized “cone of depression” with the maximum settlement of 25 cm concentrated at the wall section overlying the culvert and creek bed. As illustrated in Figure 7, numerous ground cracks about 4 m long and running perpendicular to the wall were observed along the embankment. The location and orientation of the cracks suggests they were associated with differential settlements along the base of the wall. In particular, the culvert appears to have settled during the earthquake, probably due to the presence of the soft and/or liquefiable creek bed sediments. As discussed later, it is likely that liquefaction occurred in the underlying 1-m sand layer located at a depth of 5 m. No sand boils were observed at the site or neighboring sites. However, the presence of a 2-meter thick dry crust would have likely prevented any surficial manifestation of liquefaction at depth. It is possible too that the fined-grained silty and clay strata suffered strength loss and softening and allowed earthquake-induced undrained shear distortions and settlement under the weight of the structure. Significant earthquake-induced settlements of similar fine-grained soils under loaded areas were reported at other sites in the region during the earthquake (7,8).

ground cracks

Figure 6 Northern approach embankment and damaged RE wall

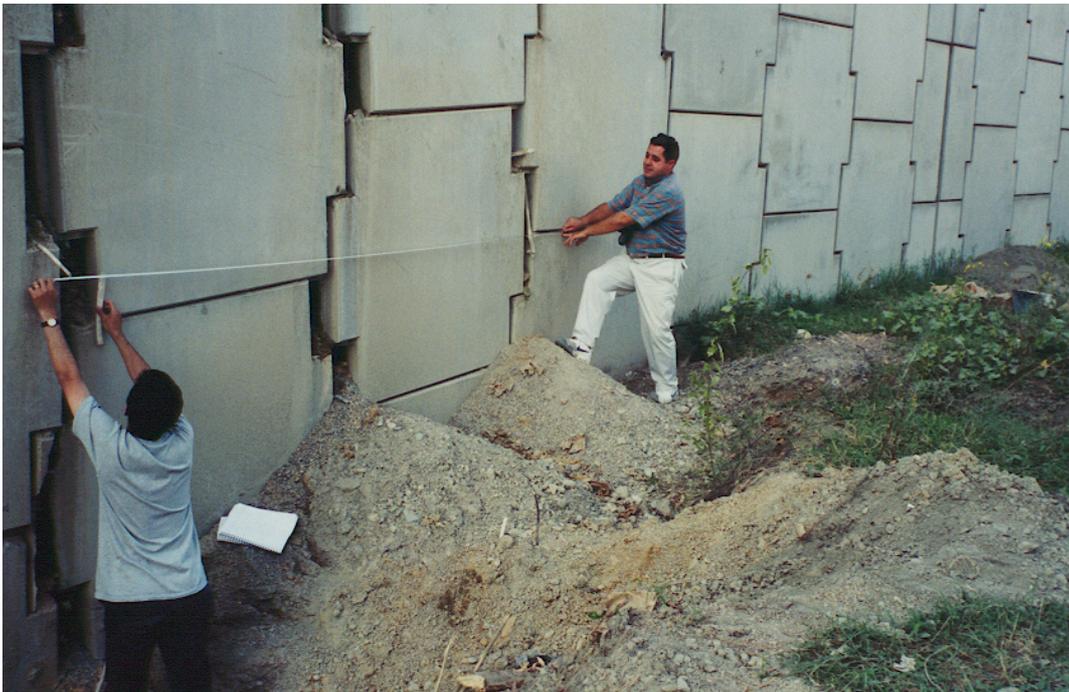
Figure 7 Separation of the facing panels and spilled backfill material

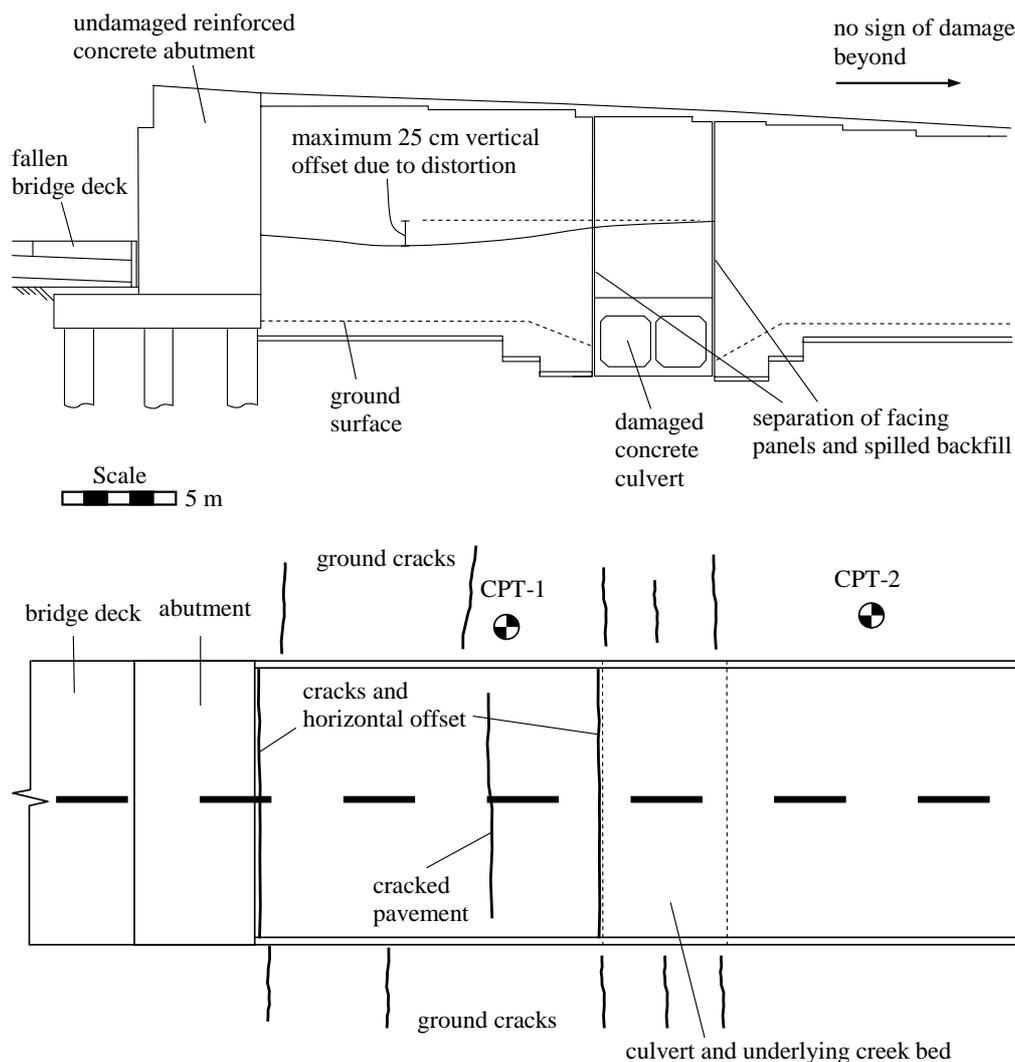
Figure 8 Damage pattern of the RE walls (front and plan views)

The slip joints used along each side of the concrete culvert and other sections of the wall apparently added to the flexibility and the structure's ability to tolerate differential settlements without being overstressed. The facing panels were intact and no signs of distress on the panels were noted. The wall was demolished several weeks following our site reconnaissance and no signs of tensile failures in connections or reinforcing strips were found.

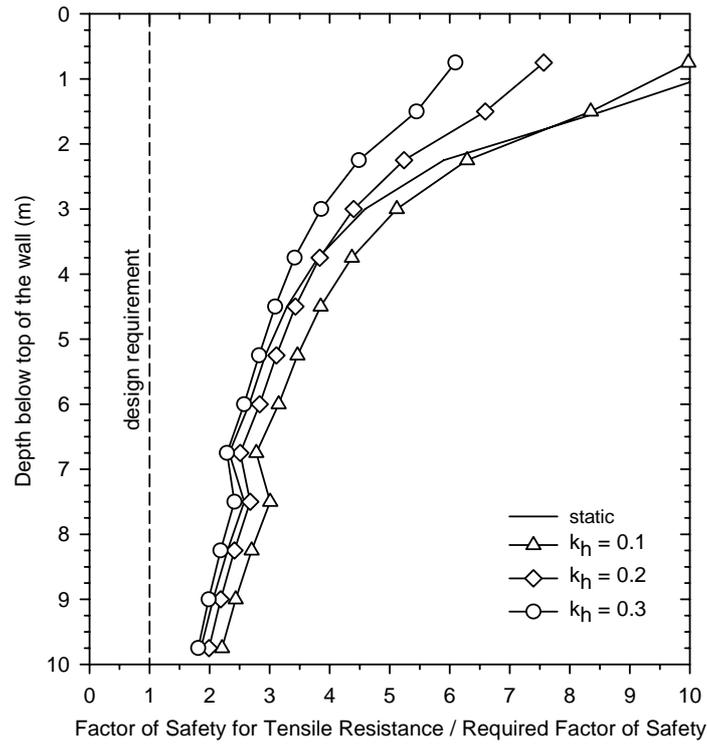
The calculated design forces for each case are compared with the allowable tensile resistance of the steel strips and the available pullout resistance at each level. Allowable tensile resistance is estimated as 55% of the tensile yield strength of steel ($\sigma_{\text{yield}} = 450 \text{ MPa} \approx 65 \text{ ksi}$ and $\sigma_{\text{allowable}} = 0.55 \sigma_{\text{yield}} = 247.5 \text{ MPa} \approx 36 \text{ ksi}$) and the available reinforcement cross-section area per unit wall width. Comparison of the available tensile resistances to the design forces and estimated actual forces are shown in Figure 9. It can be seen that the allowable capacity/demand ratio ranges from $1.9 - 11.0$ along the height of the wall for the static case. These values fall to $1.7 - 7.5, 1.5 - 5.7,$ and $1.4 - 4.6$ for conditions with seismic coefficients, k_h , of $0.1, 0.2,$ and 0.3 , respectively. The results suggest that the reinforcements should not have been stressed beyond their allowable strengths during shaking, but they were stressed much higher than the design values based on $k_h = 0.1$.

Figure 9 Tensile resistance - factor of safety for static and seismic design

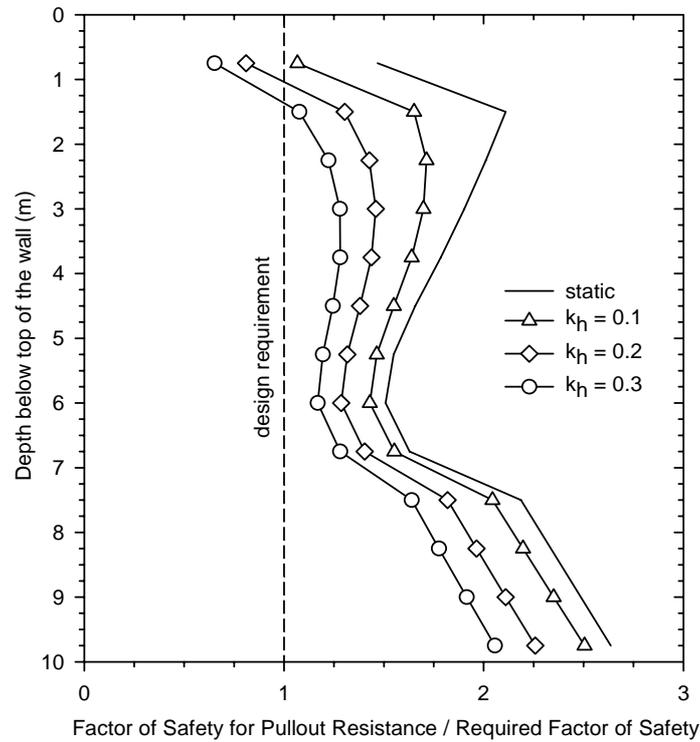
The pullout resistance for seismic loading is calculated using the friction coefficient and the surface area of the reinforcement anchored to the passive zone defined by design guidelines. Design guidelines recommend the use of a minimum 1.5 for the factor of safety against pullout at each reinforcement level. Comparison of the pullout resistances to the design forces are shown in Figure 10. As seen, the static factor of safety ranges between 2.2 and 4.0 along the height of the wall for the static case. These values drop to $1.5 - 3.5$ for a seismic coefficient of 0.1 . The factors of safety drop to a range of 1.1 to 3.0 for a seismic coefficient of 0.2 , and 0.9 to 2.9 for a seismic coefficient of 0.3 . The results suggests possible stability problems with pullout resistance during the earthquake ($k_h = 0.3$) in the upper levels.

Figure 10 Pullout resistance - factor of safety for static and seismic design

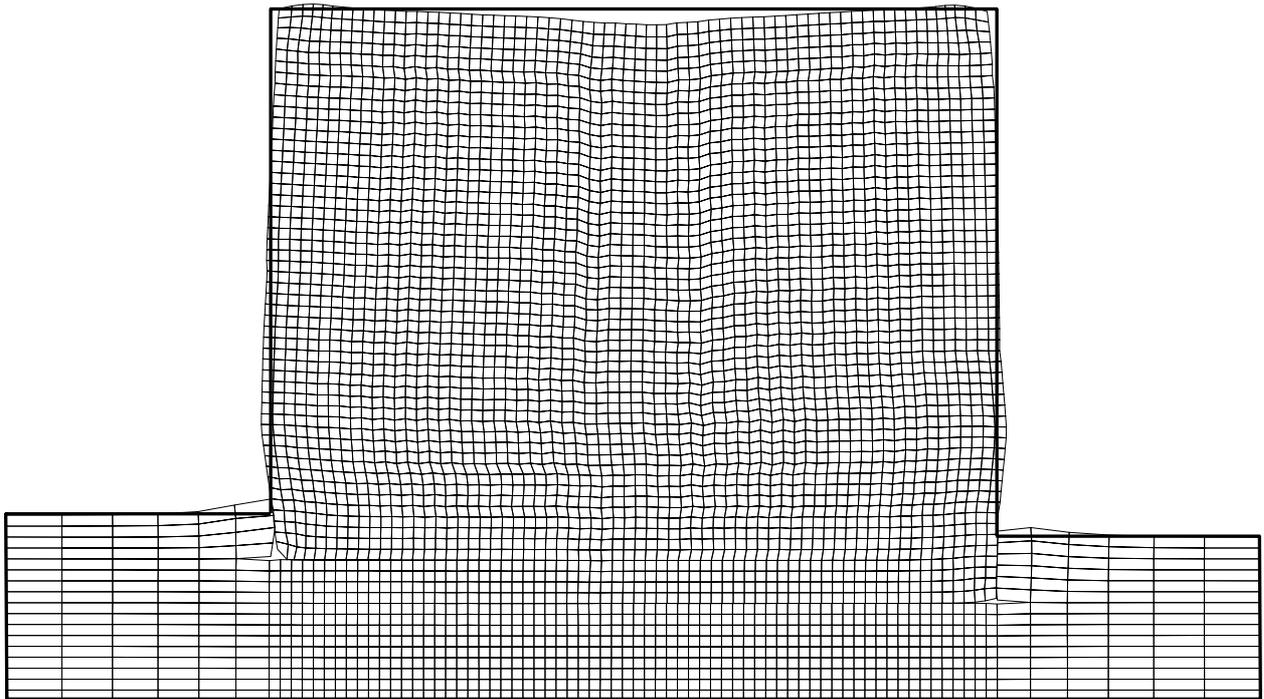
In addition to the simplified seismic analysis, numerical analyses were also performed to better understand the seismic behavior of the structure (2). Using FLAC (9) with a two-dimensional analysis, we were successful in closely predicting the observed earthquake-induced deformation pattern and displacement magnitudes of the embankment. The deformed mesh shape from the seismic analyses is provided in Figure 11. For brevity purposes, the numerical analysis details are not provided, but the main findings are summarized: 1.) a maximum earthquake-induced lateral wall displacement of 12-14 cm was predicted, compared to an observed value of 10-15 cm, and the predicted backfill settlement was 27 cm, consistent with the observed value of 25-30 cm; 2.) the observed lateral wall bulging was due mainly to seismic shaking, whereas the backfill settlement and panel misalignment were due mainly to the differential ground distortions from liquefaction- and fault-related movements; 3.) although the steel reinforcements were probably not stressed beyond their yield strengths, the earthquake-induced forces in the strips were on average 1.5 times larger than the design values; 4.) intolerable serviceability problems due to significant distortion of the structure, such as panel misalignment and significant backfill settlement, were likely to occur long before internal failure; and, 5.) consistent with the observations, the wall should have maintained its overall structural integrity despite the severe loading conditions it experienced. The numerical analysis added confidence to our interpretation of the field behavior and post-earthquake investigation of the structure.

Figure 11 Deformed shape of the finite difference grid after shaking (deformations 1x - no exaggeration)
