# PRELIMINARY FINDINGS FROM AN INVESTIGATION OF IMPROVED GROUND PERFORMANCE DURING THE 1999 TURKEY EARTHQUAKES

James R. Martin II<sup>1</sup>, C. Guney Olgun<sup>1</sup>, James K. Mitchell<sup>1</sup>,  
H. Turan Durgunoglu<sup>2</sup>, Canan Emrem<sup>3</sup>

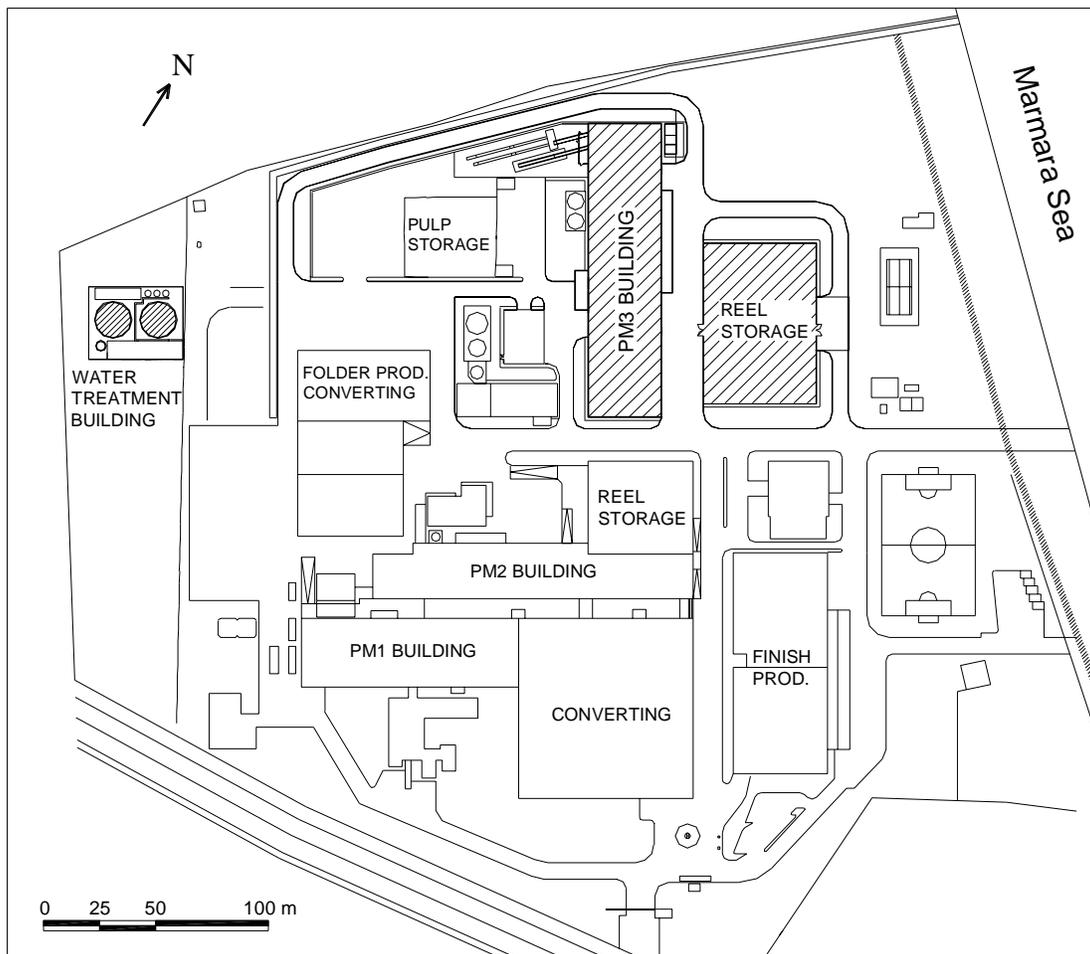
Figure 4. Ipekkagit tissue factory – site plan

The Ipekkagit Tissue Factory is located along the southern waterfront of Izmit Bay, The site lies approximately 4 km from the fault rupture. Maximum acceleration at the site reached about 0.3g during the main shock as estimated from nearby recordings and distance to the zone of energy release. General layout of the site is shown in Figure 4. The soils at the site consist of alternating strata of clay and sand that were improved for the support of shallow foundations. Geotechnical data were available from recent construction projects at the plant (Zetas 1997, 1998a) Following the earthquake, visual inspections revealed minor structural damage in an older building that was founded on unimproved ground. No structural or ground damage occurred in areas where the soils were improved.

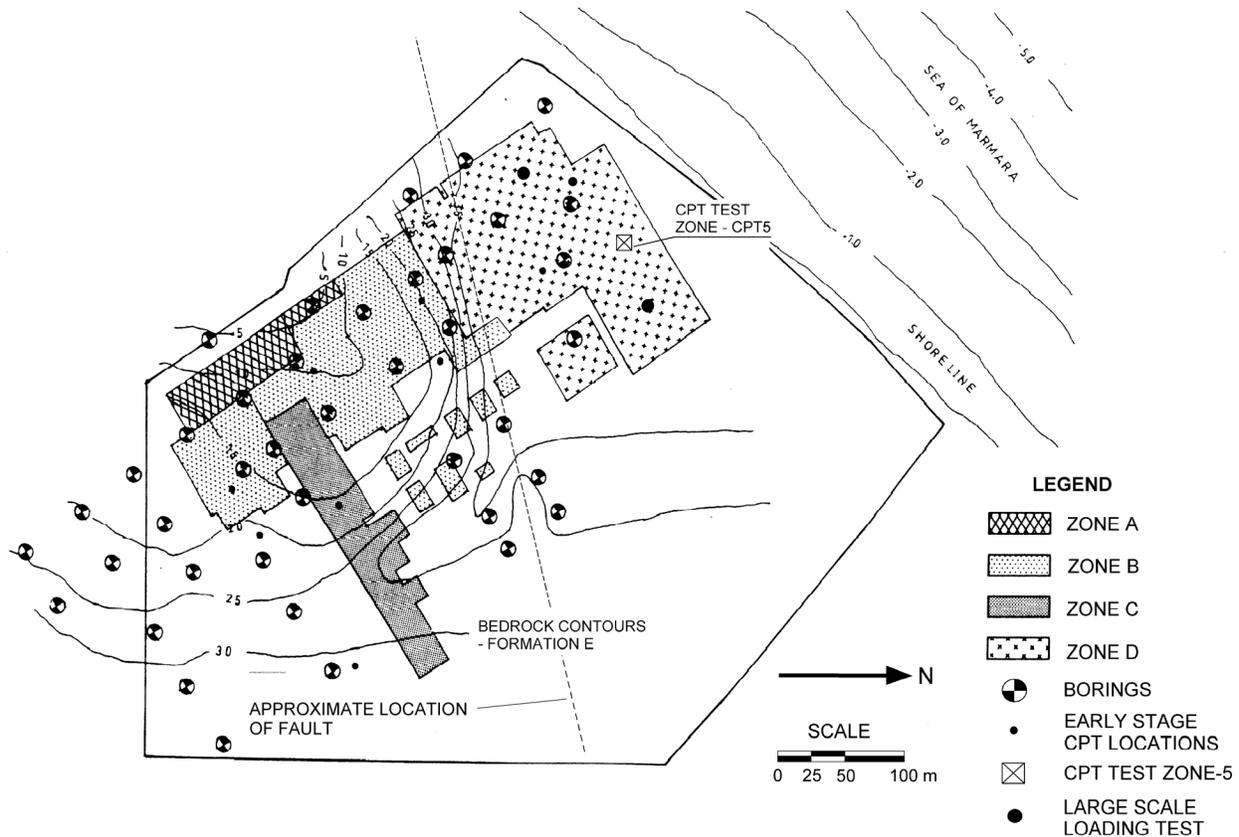
Figure 6. Borcelik steel mill – site plan

The Borcelik Steel Rolling Mill is located near the town of Gemlik, about 50 km from the earthquake epicenter and 35 km from the zone of energy release of the earthquake. Accelerometer recordings in Gemlik indicate that peak ground accelerations on rock were 0.10g. The soil profile is highly variable, consisting of a mixture of sensitive soft clays and liquefiable sands. Stone columns were installed to provide blanket treatment of the site. Ground shaking levels at the plant were relatively low during the main shock, and no structural or ground damages were observed.)
